Performance and Preservation: Retrofitting a Gothic Church

EAST LIBERTY PRESBYTERIAN CHURCH

Pittsburgh, Pennsylvania

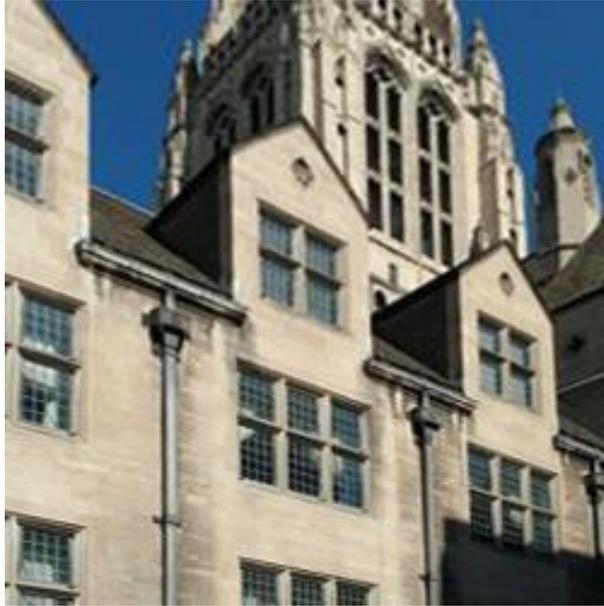
Passive first

Passive House principles provided decision-making hierarchy

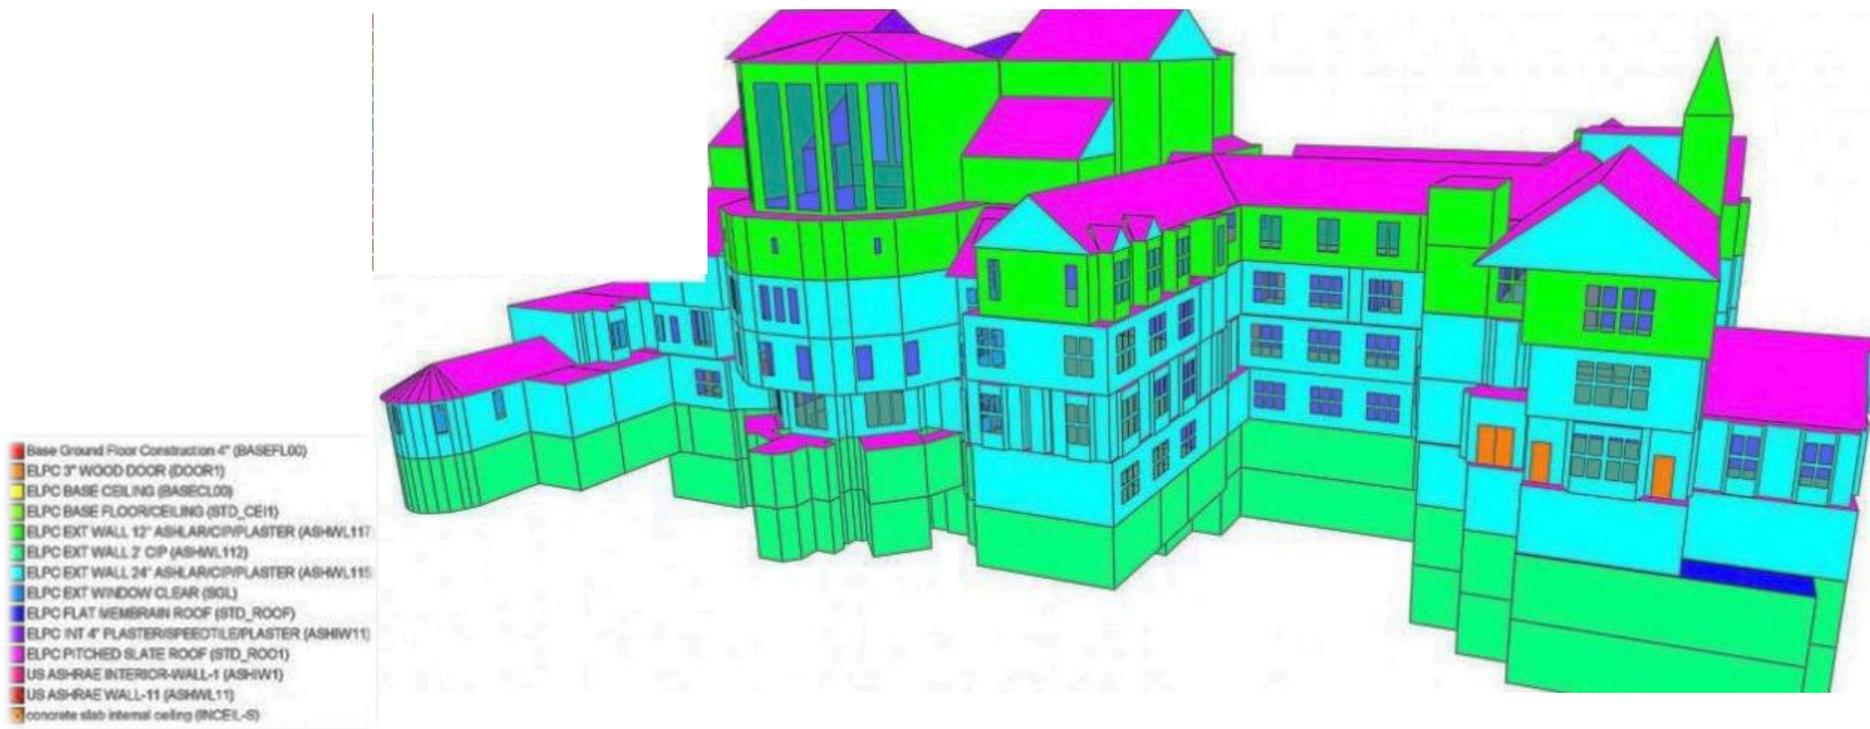
A detailed energy model informed goals and choices

Site EUI – Existing **83.6**
(kBtu/sf/yr)

Site EUI – Goal **58.6**
(kBtu/sf/yr)

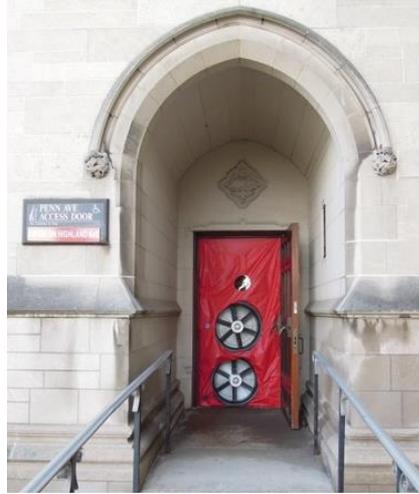
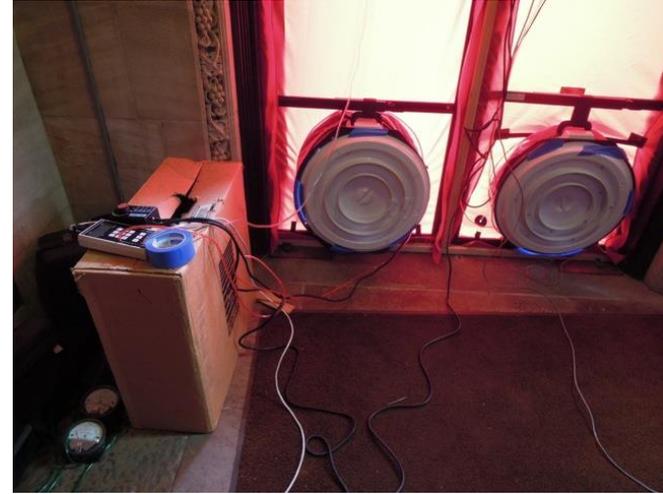
Air Leakage: on the leaky side of average (0.5 cfm/sf)*

Leaks:

- Window frames (broken operators, corroded surfaces)
- Doors
- Mechanical shafts, ducts, and penetrations

Whole-building blower-door testing measured air infiltration

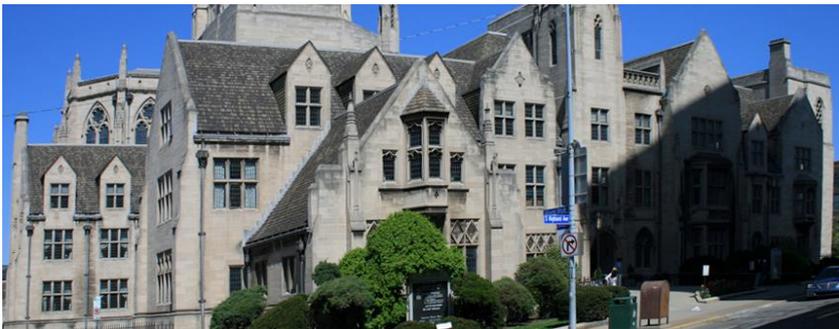
Problem: knowledge of the building handed down over time

Solution: do a thorough exploration and inventory of the building

Benefits: able to take advantage of the building's existing resources to reduce energy use

Strategy 1: Get to know the building in detail

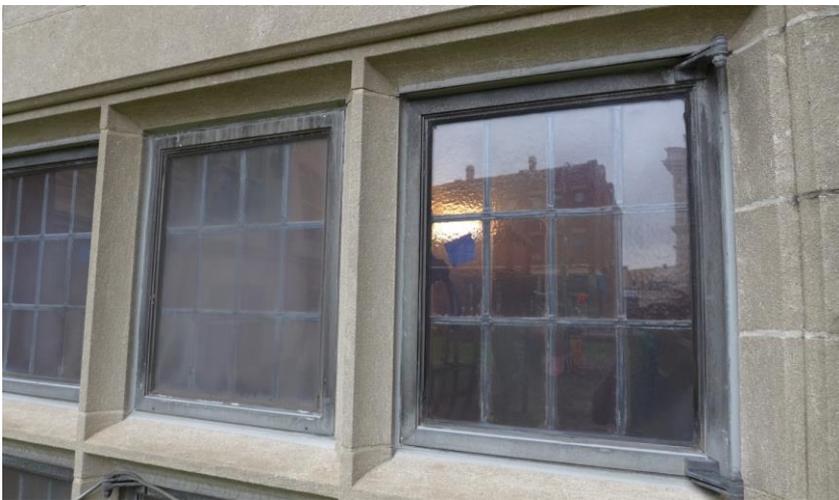
Strategy 2: Improve the envelope

Problem: historic architecture with 3 foot thick uninsulated stone walls and leaded glass windows

Solution: repair and weatherstrip windows and add exterior glass doors at entrances

Benefits: reduced heating costs; reduced humidity, reduced particulate matter resulted in increased comfort

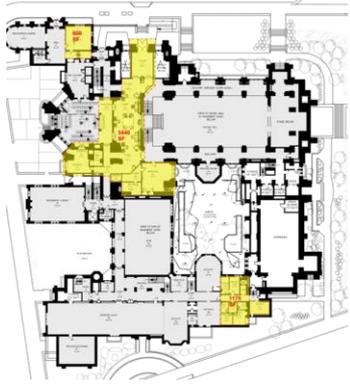
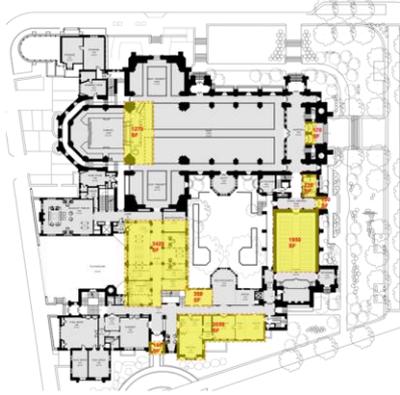
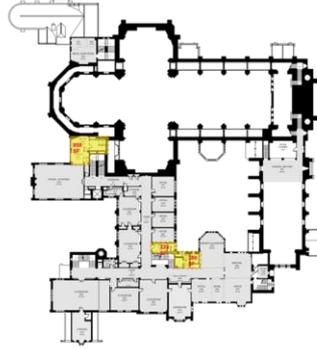
Strategy 3: Take advantage of naturally comfortable space

Problem: activities in warmest rooms while cooler space was underutilized

Solution: renovate ground floor to accommodate third floor uses

Benefits: increased capacity and occupant comfort

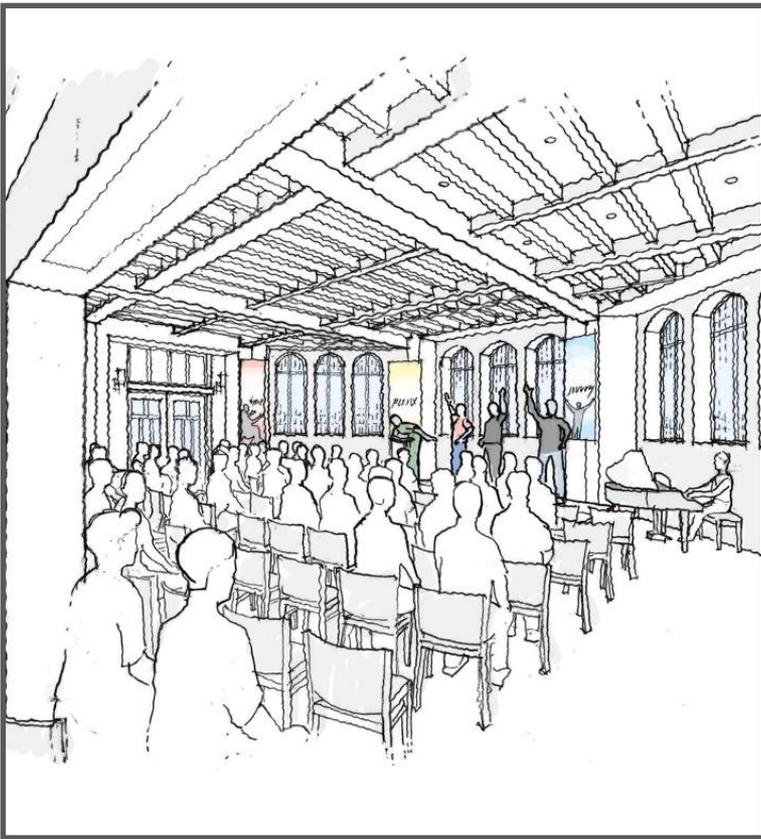
Strategy 5: Replace air conditioners with ventilation

Problem: window air conditioners had been added to individual meeting rooms and offices while building lacked required ventilation

Solution: install new DOAS system to improve ventilation and reduce humidity

Benefits: greater comfort with less energy consumption, more usable space

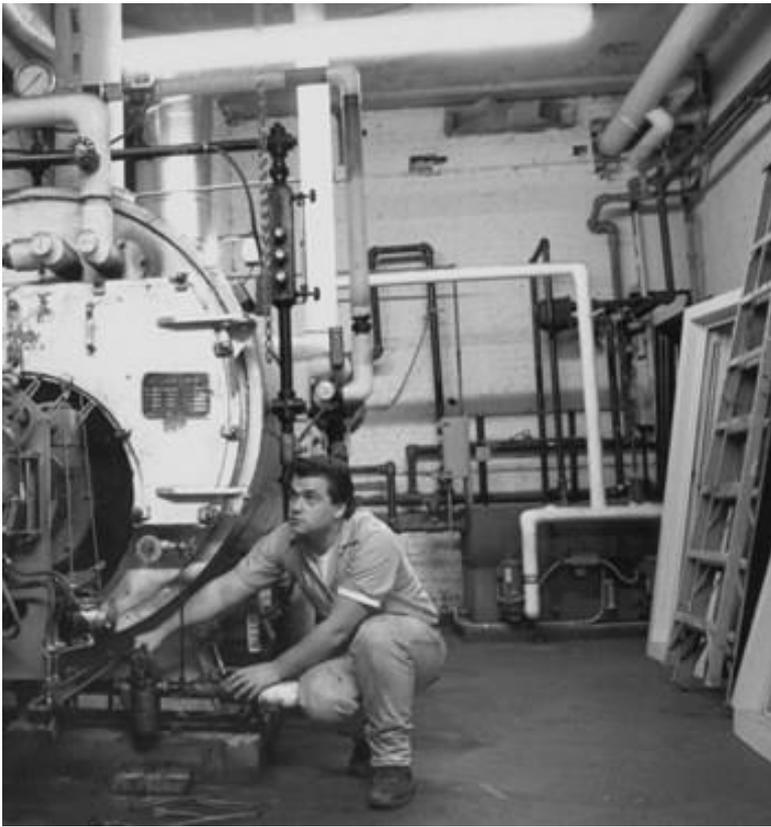
Strategy 6: Update controls on heating system

Problem: boiler and radiator system had original manual controls

Solution: install an electronic control system

Benefits: ability to respond to changes in outside conditions and program night purges

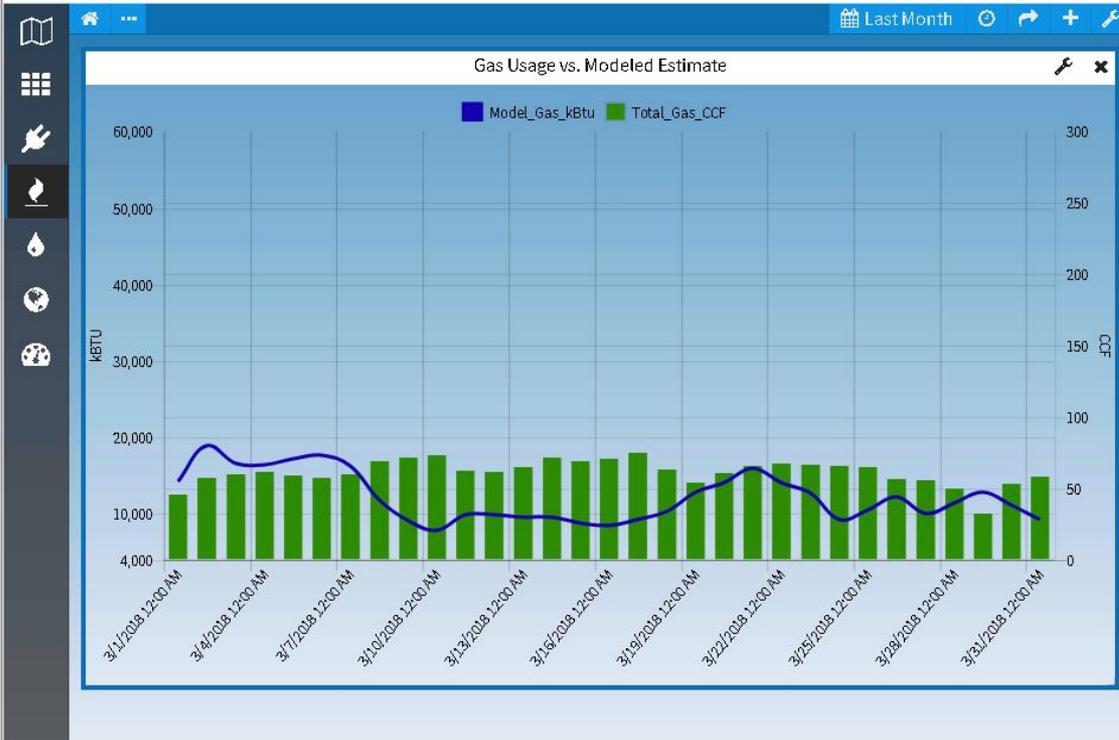
Strategy 7: Develop facilities management program

Customized dashboard makes it easy to see how the building is performing compared to the targets.

Divergences are instantly transmitted to facility manager.

Problem: Conventional maintenance cannot optimize performance over time

Solution: Digital management tools were developed; smart infrastructure designed to be easy to use

Benefits: Ongoing commissioning for long term performance management; performance gaps immediately visible
