# **HSBC Place - Deep Energy Retrofit** (2017)

- Approx. 318,000 sq. ft., 18-storey commercial office building
- Located in downtown Edmonton, AB
- Originally constructed in 1980

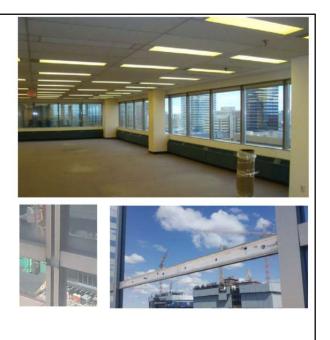
### **Building Envelope - Before**

- Double-pane insulated glass in curtain wall with aluminum frames
- 300 reported window seal failures indicates end of life
- Operations report systemic leaks in the curtain wall and condensation in the winter
- Thermal performance very poor

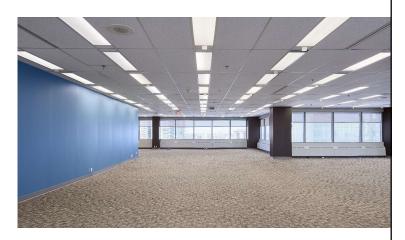
# **Lighting - Before**

- · 347V fluorescent lighting
- ON/OFF relay lighting controls
- No centralized controls
